**Flood Control Project Maintenance
Levee Inspections****LMA District Cover Sheet****Spring 2011 Levee Inspection Results****San Joaquin County Flood Control and Water Conservation District**

Spring 2011 Levee Inspection Results

San Joaquin County Flood Control and Water Conservation District

Waterway			Bank	Unit Miles
Unit No. 01 Littlejohn Creek			Left	2.87

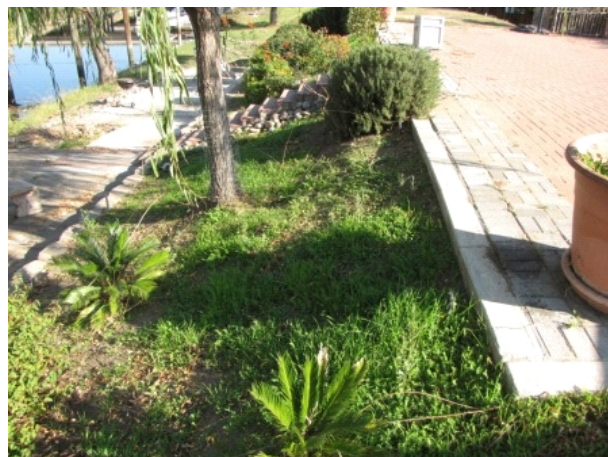
pkazi_s_20110328_126.jpg

Levee Mile Report Line	22
Start Levee Mile	0.83
End Levee Mile	0.84
Location	Water Side
Category	Earthen Levee
Item	Encroachments

View of landscaping and irrigation on the waterward slope looking upstream.

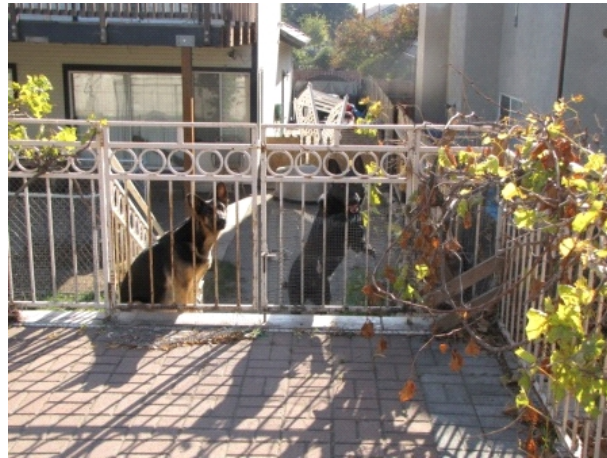
pkazi_s_20110328_125.jpg

View of steps on the landward slope and dogs preventing a closer inspection.

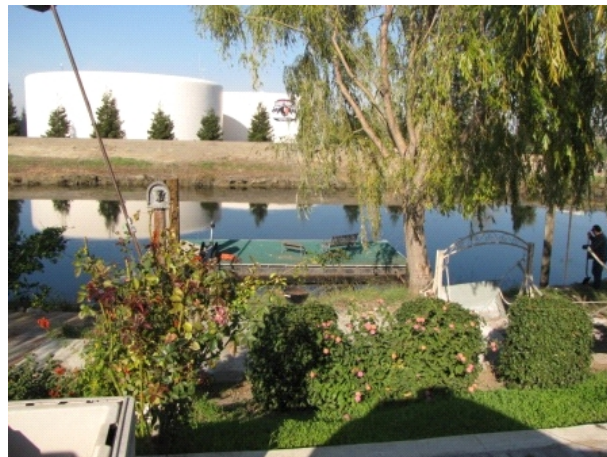
pkazi_s_20110328_129.jpg

Levee Mile Report Line	24
Start Levee Mile	0.84
End Levee Mile	0.84
Location	Water Side
Category	Earthen Levee
Item	Encroachments

View of a dock on the waterward side of the berm.

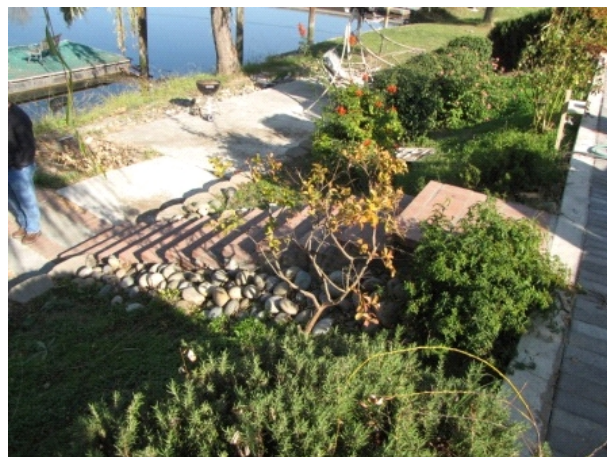
pkazi_s_20110328_128.jpg

Levee Mile Report Line	25
Start Levee Mile	0.84
End Levee Mile	0.84
Location	Water Side
Category	Earthen Levee
Item	Encroachments

View of steps on the waterward slope of the levee looking upstream.

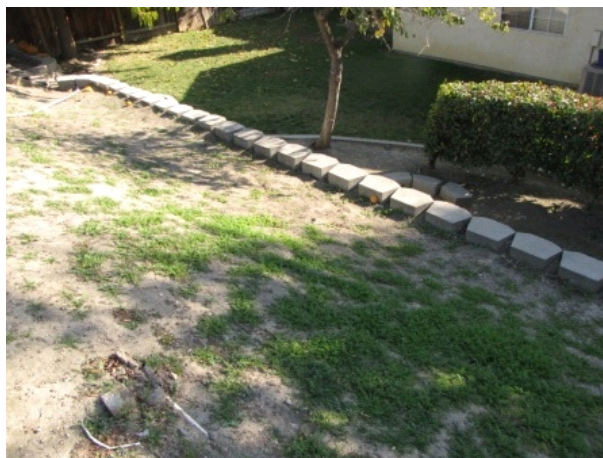
pkazi_s_20110328_130.jpg

View of a retaining wall in the landward slope.

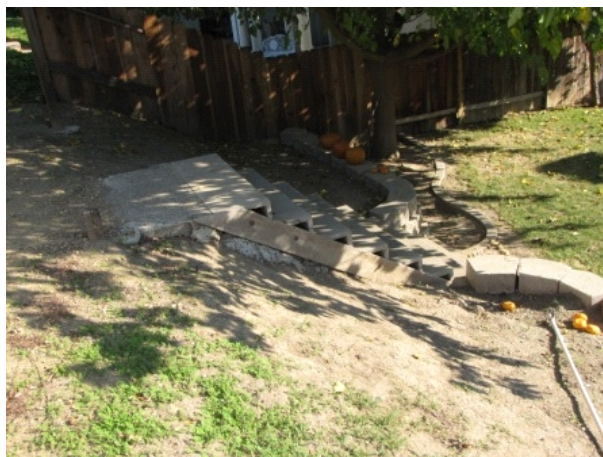
pkazi_s_20110328_131.jpg

Levee Mile Report Line	27
Start Levee Mile	0.85
End Levee Mile	0.85
Location	Land Side
Category	Earthen Levee
Item	Encroachments

View of steps on the landward slope looking upstream.

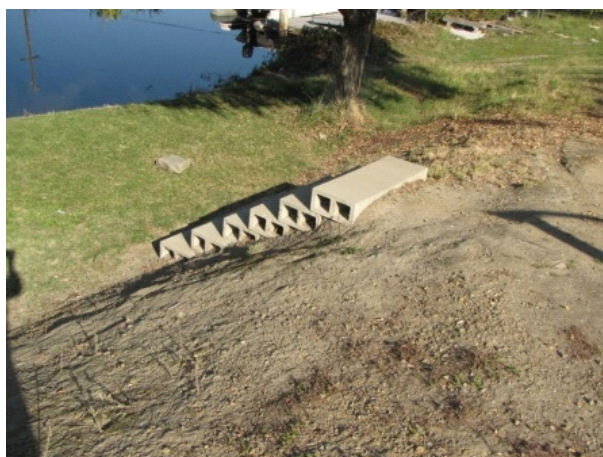
pkazi_s_20110328_132.jpg

Levee Mile Report Line	28
Start Levee Mile	0.85
End Levee Mile	0.85
Location	Water Side
Category	Earthen Levee
Item	Encroachments

View of steps on the waterward slope looking upstream.

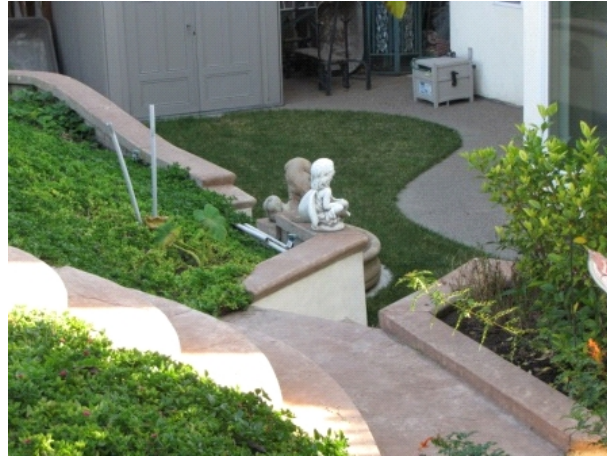
pkazi_s_20110328_134.jpg

View of a retaining wall and patio in the landward slope.

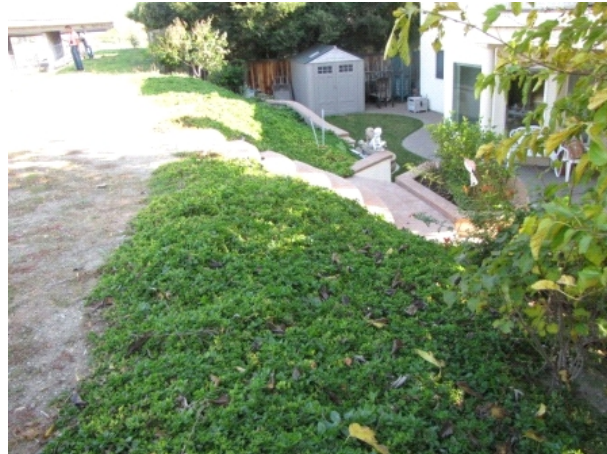
pkazi_s_20110328_133.jpg

View of landscaping and irrigation on the landward slope looking upstream.

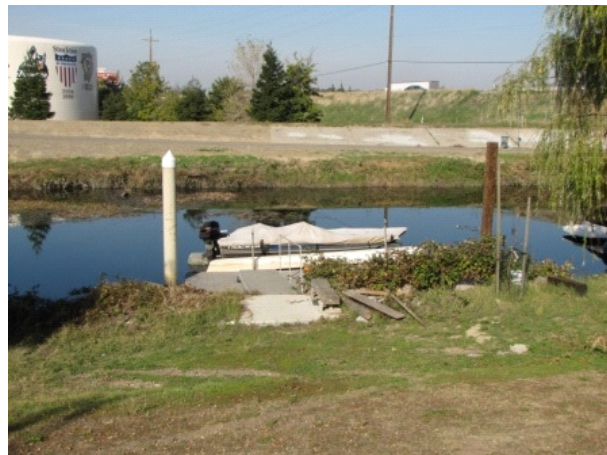
Levee Mile Report Line	31
Start Levee Mile	0.86
End Levee Mile	0.86
Location	Water Side
Category	Earthen Levee
Item	Encroachments

View of a dock and concrete pad on the waterward side of the berm.

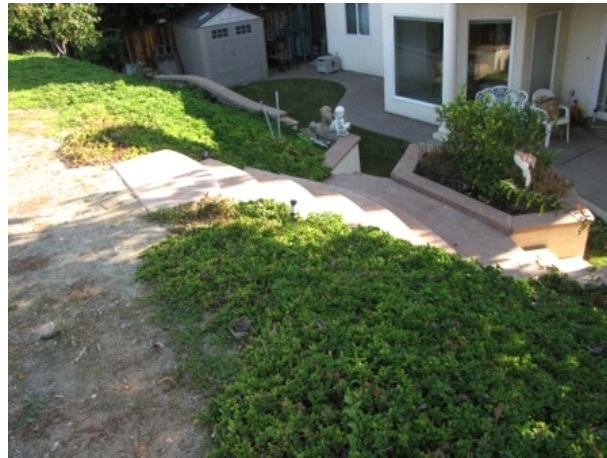
pkazi_s_20110328_135.jpg

View of steps on the landward slope looking upstream.

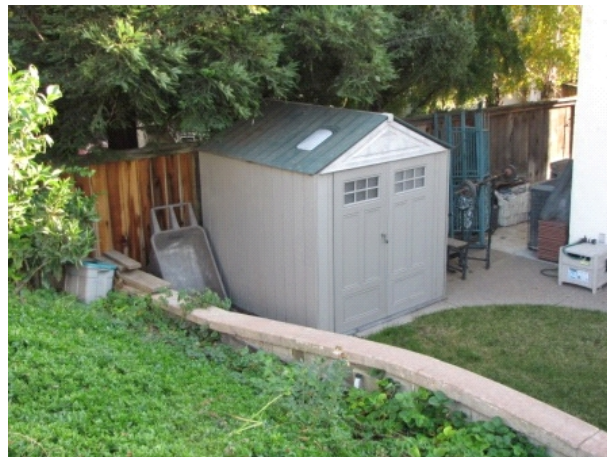
Levee Mile Report Line	33
Start Levee Mile	0.87
End Levee Mile	0.87
Location	Land Side
Category	Earthen Levee
Item	Encroachments

View of a shed located at the landward toe looking upstream.

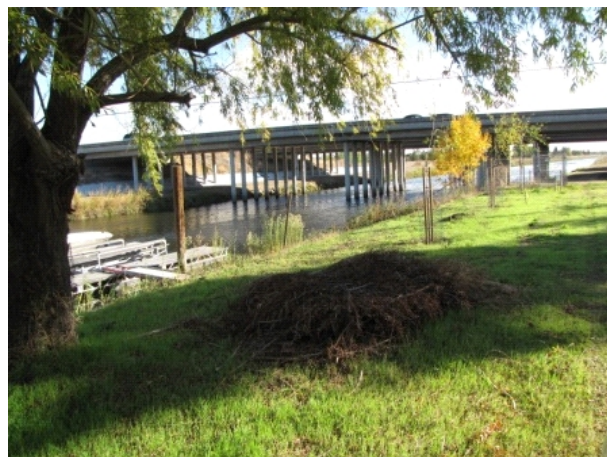
Levee Mile Report Line	34
Start Levee Mile	0.87
End Levee Mile	0.87
Location	Water Side
Category	Earthen Levee
Item	Encroachments

View of a prunings pile on the waterward berm looking upstream.

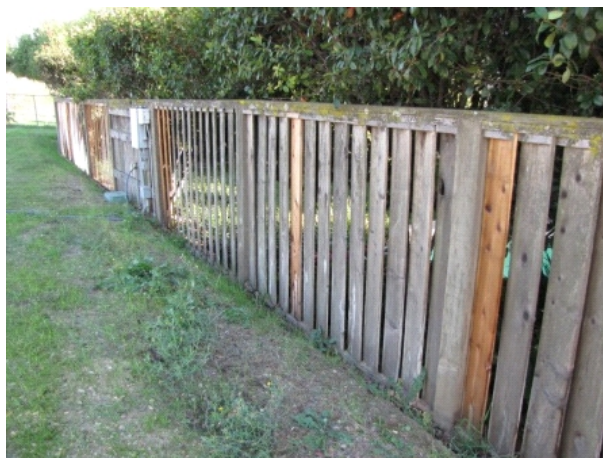
pkazi_s_20110328_138.jpg

View of a fence at the landward shoulder blocking visibility and access looking upstream. Some encroachments can be seen through the fence but not with any detail. Also visible is an electrical panel and hose bib.

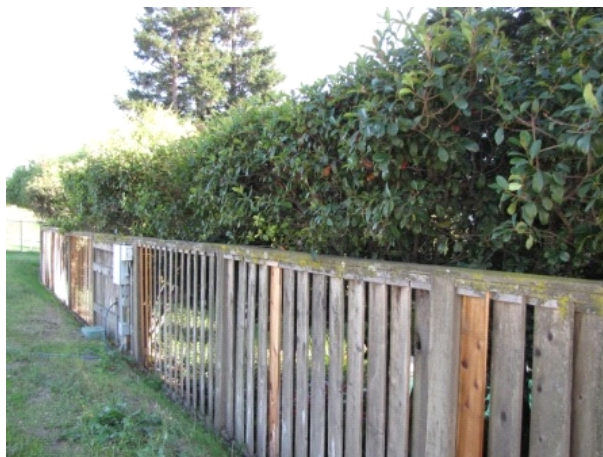
Levee Mile Report Line	36
Start Levee Mile	0.87
End Levee Mile	0.88
Location	Land Side
Category	Earthen Levee
Item	Encroachments

View of bushes above the fence at the landward shoulder further obstructing visibility looking upstream.

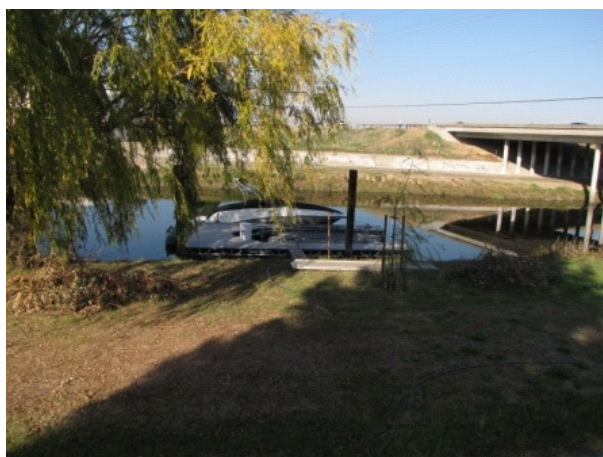
Levee Mile Report Line	37
Start Levee Mile	0.88
End Levee Mile	0.88
Location	Water Side
Category	Earthen Levee
Item	Encroachments

View of a dock on the waterward side of the berm.

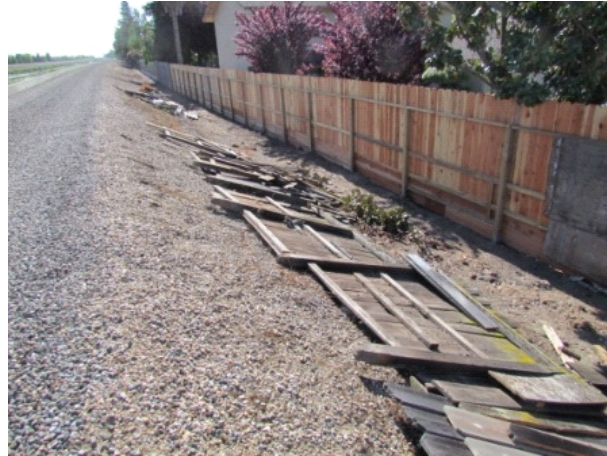
pkazi_s_20110429_484.jpg

Picture of the old wood fences along with some debris on the landside of the levee. The picture was taken from the crown of the levee looking upstream.

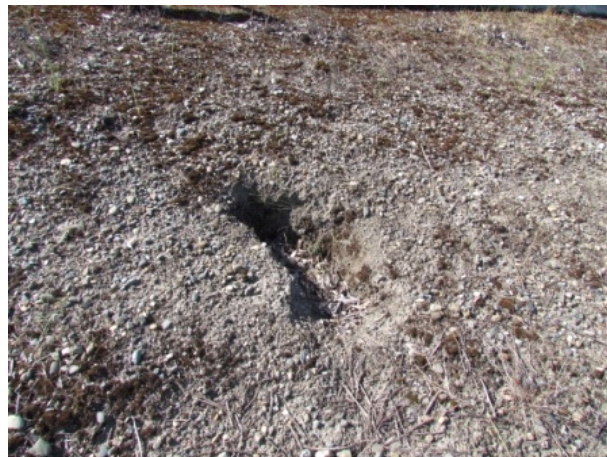
Levee Mile Report Line	43
Start Levee Mile	1.57
End Levee Mile	1.57
Location	Water Side
Category	Earthen Levee
Item	Animal Control

Rodent hole was found on the waterside of the levee. The picture was taken from the toe at the water side of the levee looking towards the crown.

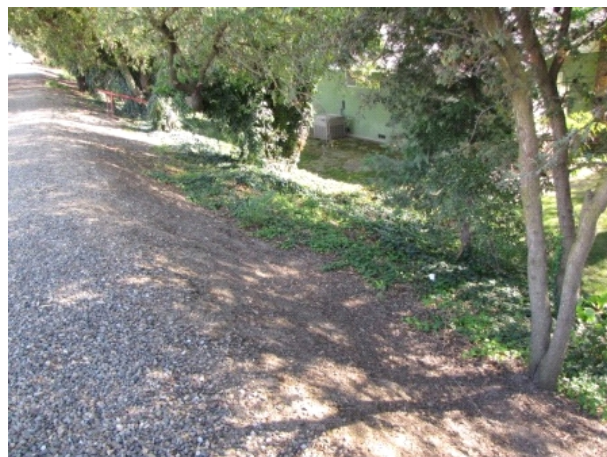
Levee Mile Report Line	48
Start Levee Mile	2.04
End Levee Mile	2.07
Location	Land Side
Category	Earthen Levee
Item	Encroachments

View of landscaping along the landward slope looking upstream. County crews have greatly reduced the amount of material and increased visibility and access.

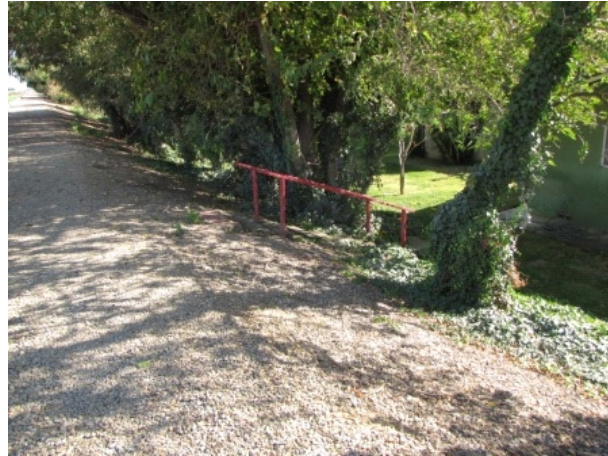
pkazi_s_20110328_095.jpg

View of steps dug into the landward slope looking upstream.

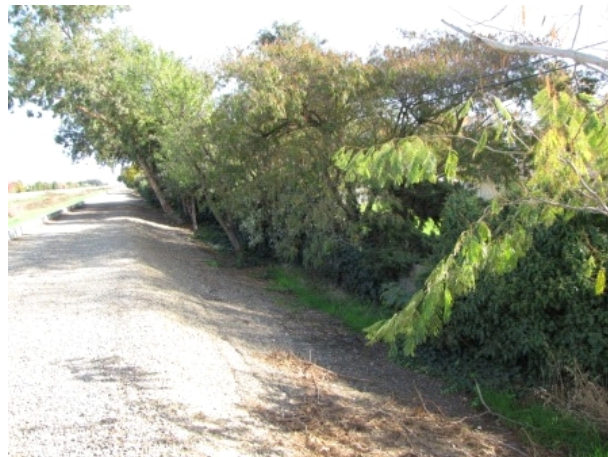
Levee Mile Report Line	51
Start Levee Mile	2.11
End Levee Mile	2.14
Location	Land Side
Category	Earthen Levee
Item	Encroachments

51	2.11	2.14	Earthen Levee	Encroachments	LS	CO	Fences Inspector Comments: The fence is covered by ivy.	38.042797 ° -121.346087 °	38.042787 ° -121.345608 °	1008 Y
52	2.14	2.16	Earthen Levee	Encroachments	LS	CO	Landscaping	38.042786 ° -121.345607 °	38.042779 ° -121.345154 °	1009 Y
53	2.17	2.19	Earthen Levee	Encroachments	LS	CO	Fences Inspector Comments: Wood fence on landward toe.	38.042779 ° -121.345119 °	38.042775 ° -121.344777 °	1011 Y
54	2.19	2.19	Earthen Levee	Slope Stability	LS	M	Repair the levee slope damaged by foot traffic and prevent access where possible.	38.042760 ° -121.344784 °	38.042760 ° -121.344784 °	38 Y
55	2.19	2.25	Earthen Levee	Encroachments	LS	CO	Fences Inspector Comments: Wood fence on landward toe.	38.042775 ° -121.344777 °	38.042773 ° -121.343691 °	1012 Y
56	2.22	2.22	Earthen Levee	Encroachments	LS	C	Prunings	38.042751 ° -121.344156 °	38.042751 ° -121.344156 °	9
57	2.25	2.30	Earthen Levee	Encroachments	LS	CO	Fences Inspector Comments: Wood fence on the landward slope.	38.042764 ° -121.343690 °	38.042765 ° -121.342620 °	1018 Y

View of a fence with landscaping growing on it at the landward toe looking upstream.

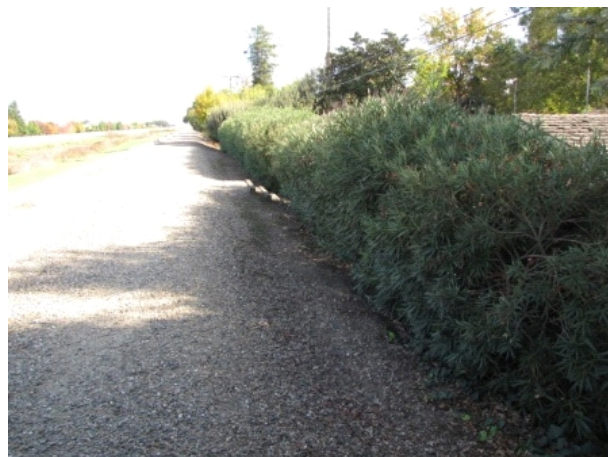
Levee Mile Report Line	52
Start Levee Mile	2.14
End Levee Mile	2.16
Location	Land Side
Category	Earthen Levee
Item	Encroachments

View of landscaping along the landward slope looking upstream.

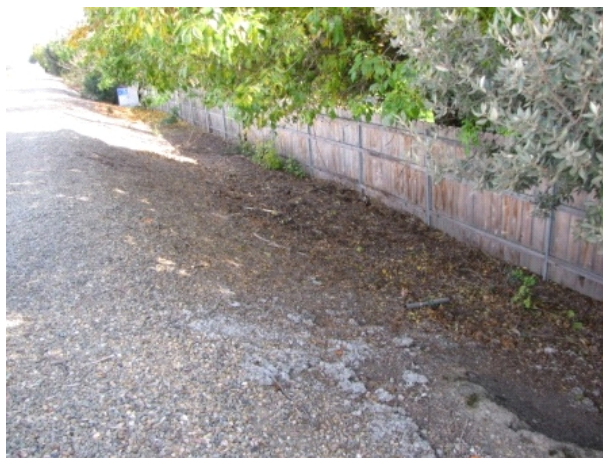
pkazi_s_20110328_098.jpg

View of a fence along the landward toe looking upstream.

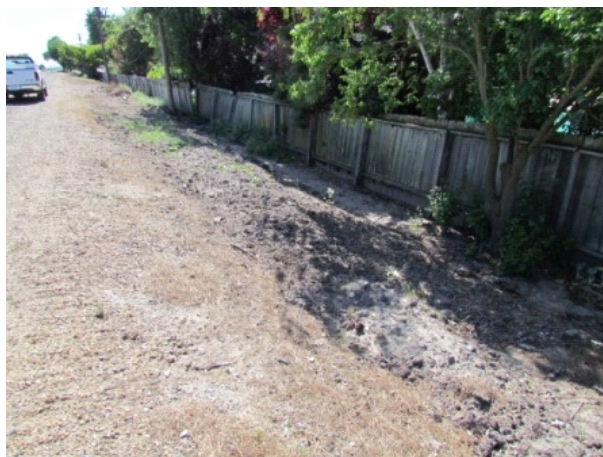
Levee Mile Report Line	54
Start Levee Mile	2.19
End Levee Mile	2.19
Location	Land Side
Category	Earthen Levee
Item	Slope Stability

Additional soil was placed by the owner of the property on the landside of the levee. The picture was taken from the crown of the levee looking upstream.

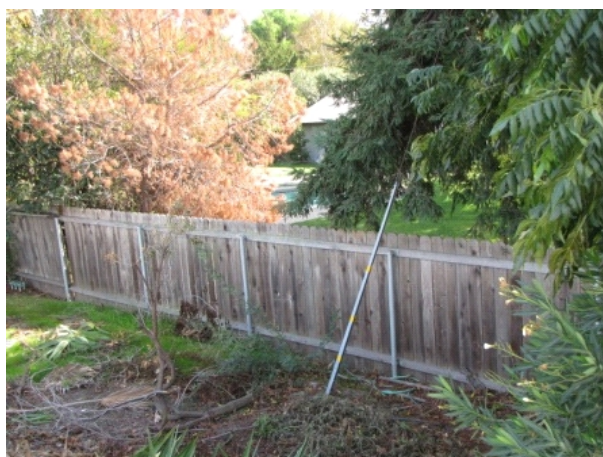
Levee Mile Report Line	55
Start Levee Mile	2.19
End Levee Mile	2.25
Location	Land Side
Category	Earthen Levee
Item	Encroachments

View of a fence along the landward toe.

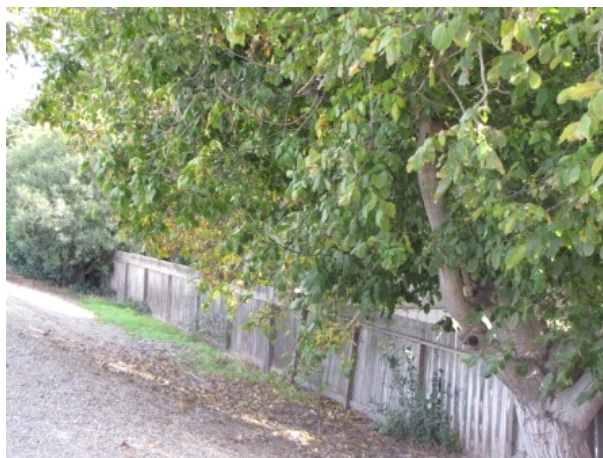
pkazi_s_20110328_100.jpg

View of a wood fence at the landward toe.

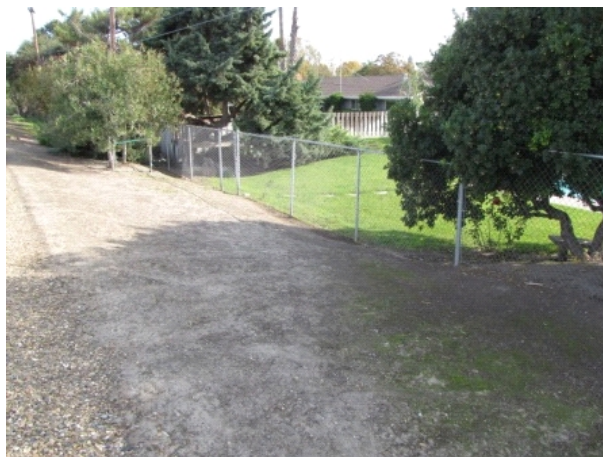
Levee Mile Report Line	58
Start Levee Mile	2.30
End Levee Mile	2.38
Location	Land Side
Category	Earthen Levee
Item	Encroachments

View of a fence on the landward slope looking upstream.

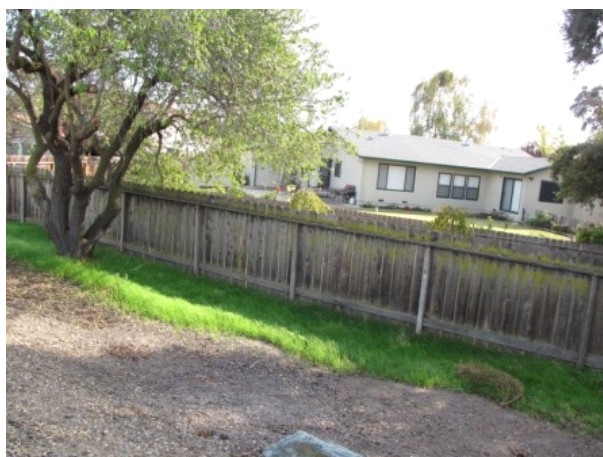
Levee Mile Report Line	60
Start Levee Mile	2.38
End Levee Mile	2.40
Location	Land Side
Category	Earthen Levee
Item	Encroachments

View of a fence at the landward toe.

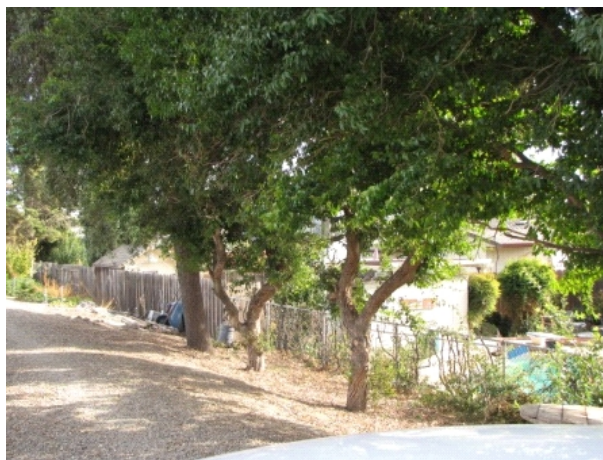
pkazi_s_20110328_103.jpg

View of a fence at the landward toe.

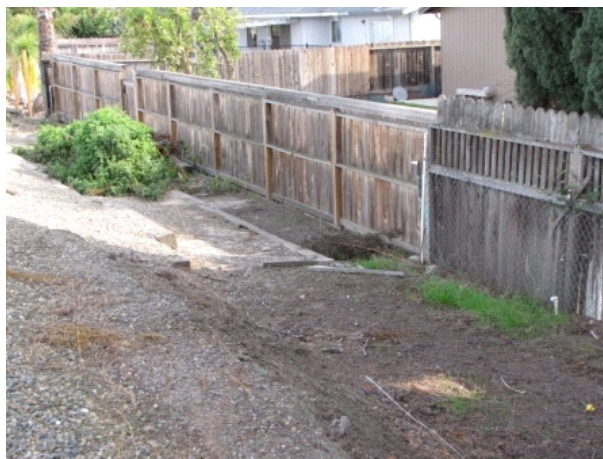
Levee Mile Report Line	62
Start Levee Mile	2.43
End Levee Mile	2.69
Location	Land Side
Category	Earthen Levee
Item	Encroachments

View of a fence at the landward toe looking upstream.

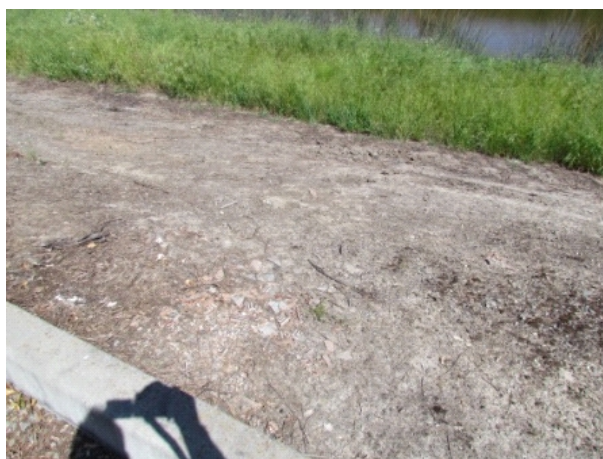
Levee Mile Report Line	64
Start Levee Mile	2.45
End Levee Mile	2.45
Location	Water Side
Category	Earthen Levee
Item	Erosion / Bank Caving

64	2.45	2.45	Earthen Levee	Erosion / Bank Caving	WS	A	Note and monitor erosion site. Inspector Comments: The erosion site has been repaired.	38.042744 ° -121.340270 °	38.042744 ° -121.340270 °	123 Y

No erosion was found on the waterside of the levee. The picture was taken from the crown looking downstream.

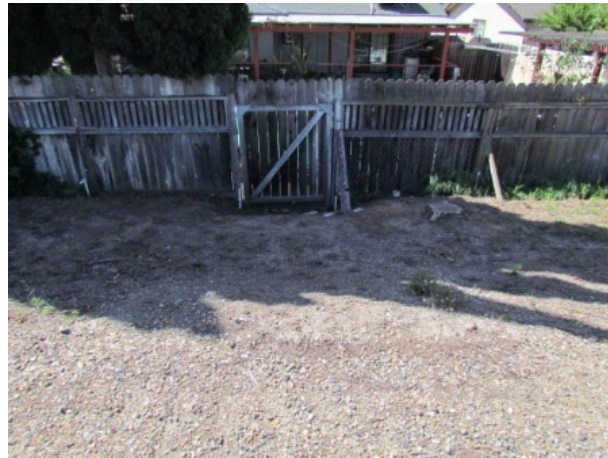
pkazi_s_20110502_503.jpg

No visible damage at the site. The picture was taken from the crown of the levee looking towards the toe of landside of the levee.

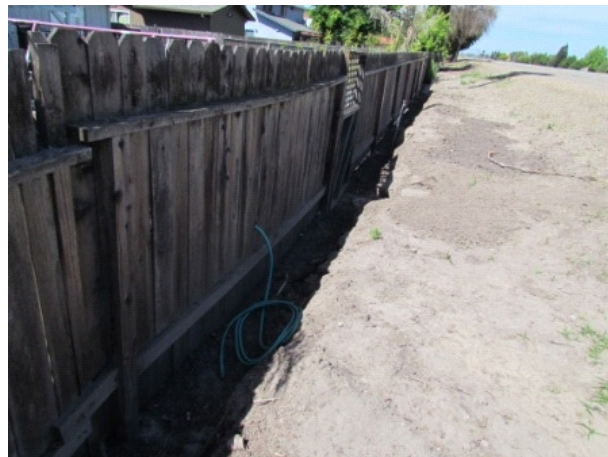
Levee Mile Report Line	66
Start Levee Mile	2.48
End Levee Mile	2.48
Location	Land Side
Category	Earthen Levee
Item	Encroachments

The owner excavated a ditch on the toe at the landside of the levee. The picture was taken from the landside of the levee looking downstream.

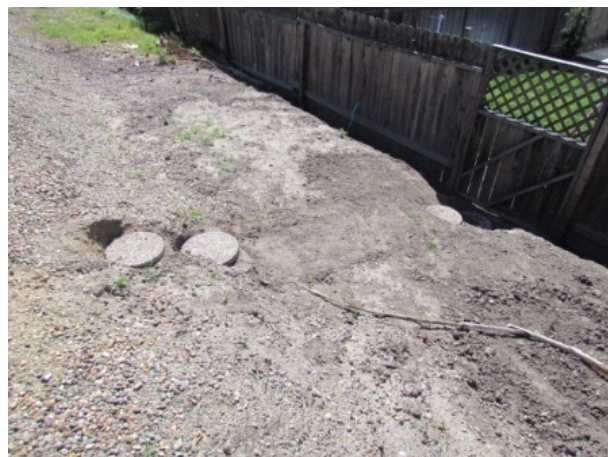
Levee Mile Report Line	67
Start Levee Mile	2.48
End Levee Mile	2.48
Location	Land Side
Category	Earthen Levee
Item	Encroachments

Landside slope was cut to place the stairways on the levee. The picture was taken from the crown of the levee looking upstream.

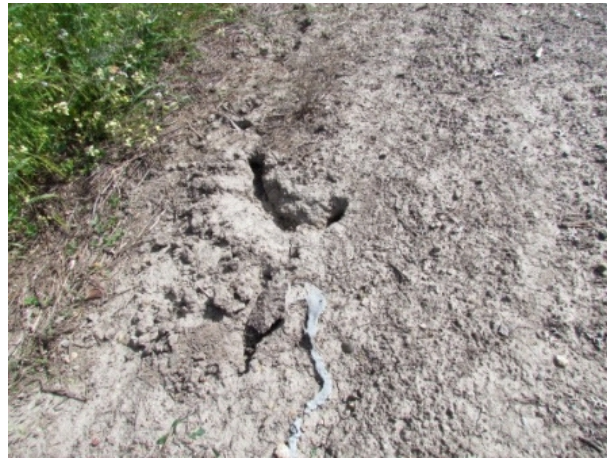
pkazi_s_20110429_489.jpg

Rodent hole washed by the water at the waterside of the levee. The picture was taken from the waterside of the levee looking upstream.

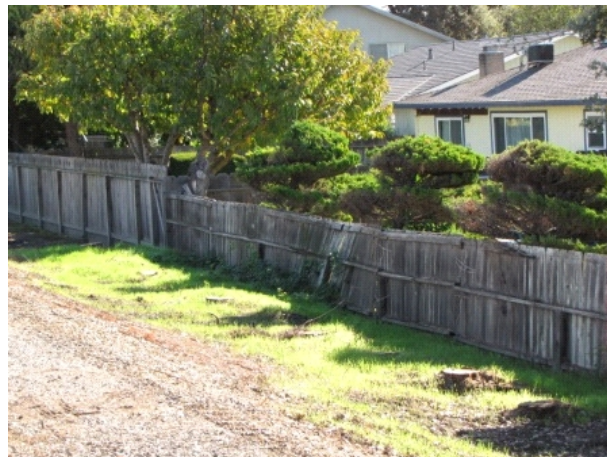
Levee Mile Report Line	69
Start Levee Mile	2.55
End Levee Mile	2.55
Location	Land Side
Category	Earthen Levee
Item	Trim / Thin Trees

View of stumps along the landward toe looking upstream.

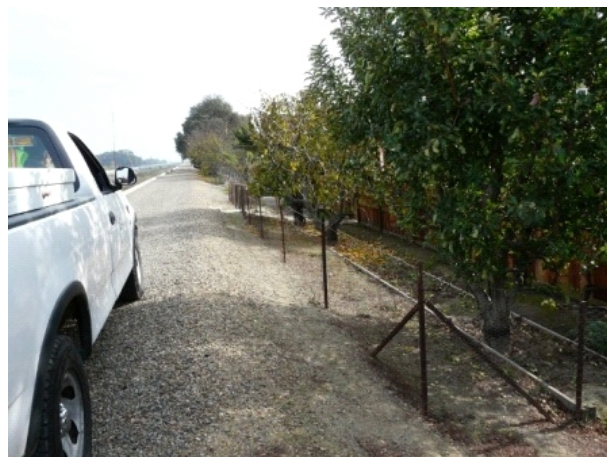
Levee Mile Report Line	70
Start Levee Mile	2.58
End Levee Mile	2.61
Location	Land Side
Category	Earthen Levee
Item	Encroachments

Fence located on sholder of landside of levee from LM 2.58 to LM 2.61

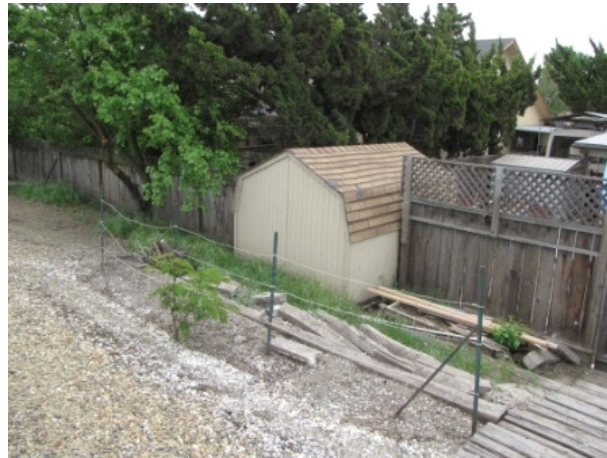
pkazi_s_20110328_091.jpg

Landscaping and shed placed on landward levee slope and within 10' of the toe.

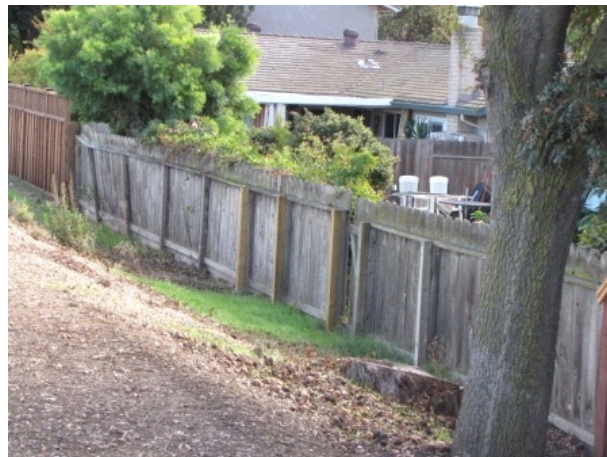
Levee Mile Report Line	79
Start Levee Mile	3.08
End Levee Mile	3.08
Location	Land Side
Category	Earthen Levee
Item	Trim / Thin Trees

View of a stump on the landward slope looking upstream.

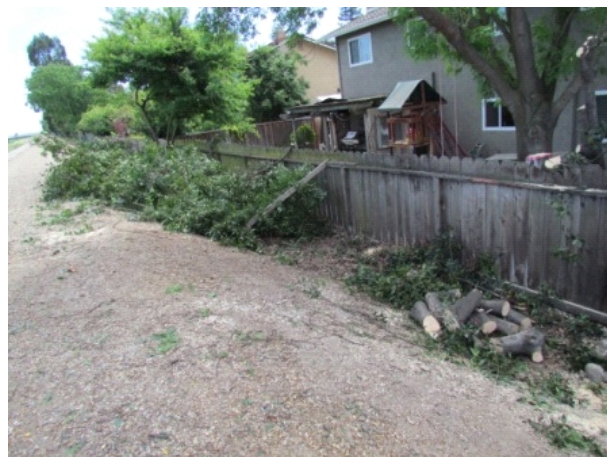
Levee Mile Report Line	80
Start Levee Mile	3.11
End Levee Mile	3.11
Location	Land Side
Category	Earthen Levee
Item	Encroachments

Tree branches along with other debris were placed on the landside of the levee. The picture was taken from the crown of the levee looking upstream.

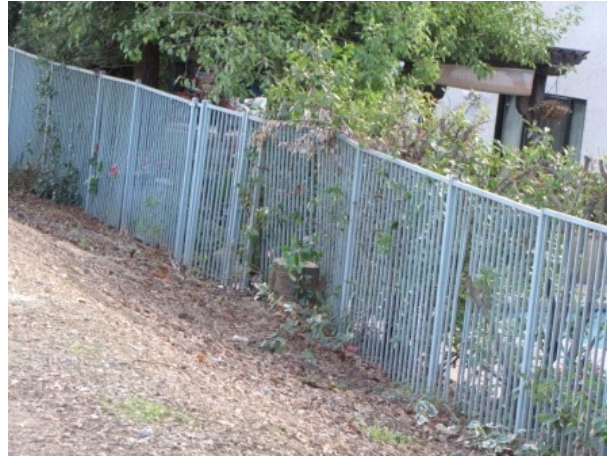
pkazi_s_20110328_072.jpg

View of a stump on the landward slope looking upstream.

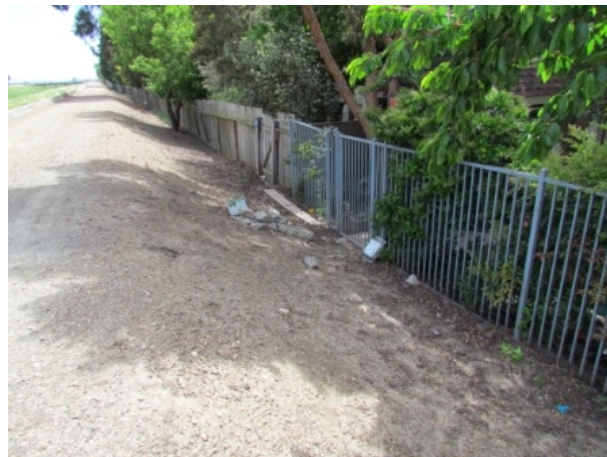
Levee Mile Report Line	82
Start Levee Mile	3.19
End Levee Mile	3.19
Location	Land Side
Category	Earthen Levee
Item	Encroachments

Debris on the landside of the levee. Picture was taken from the crown of the levee looking upstream.

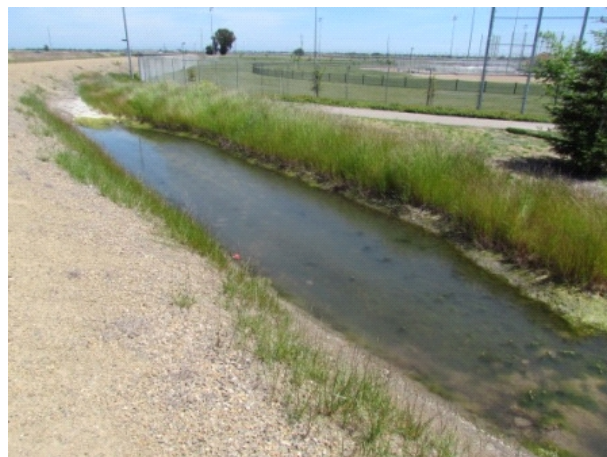
Levee Mile Report Line	90
Start Levee Mile	4.75
End Levee Mile	4.75
Location	Land Side
Category	Earthen Levee
Item	Slope Stability

Large amount of water was discovered on the toe of landside of the levee. The picture was taken from crown of the levee looking upstream.

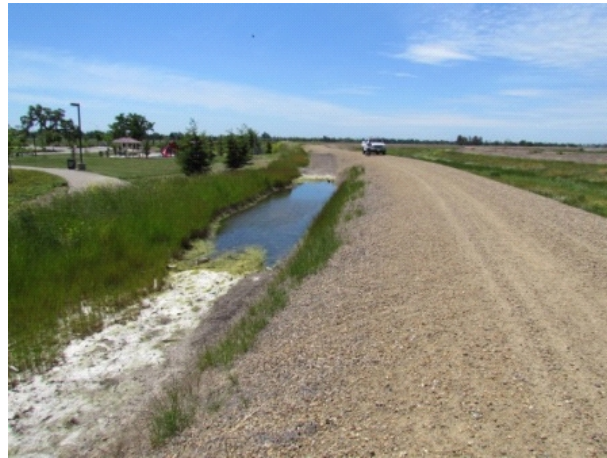
pkazi_s_20110502_505.jpg

Location of the pond of water at the toe of the landside of the levee. The picture was taken from crown looking downstream.

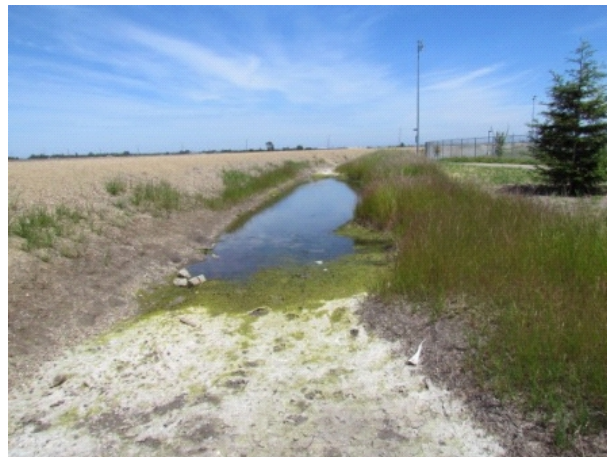
Levee Mile Report Line	90
Start Levee Mile	4.75
End Levee Mile	4.75
Location	Land Side
Category	Earthen Levee
Item	Slope Stability

Pond of water found at the toe of the landside of the levee. The picture was taken from toe of the levee looking upstream.

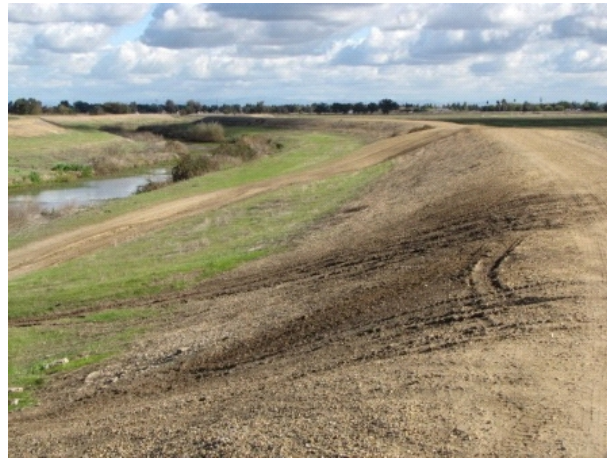
pkazi_s_20110328_075.jpg

View of damage to the waterward slope of the levee due to vehicle traffic looking upstream.

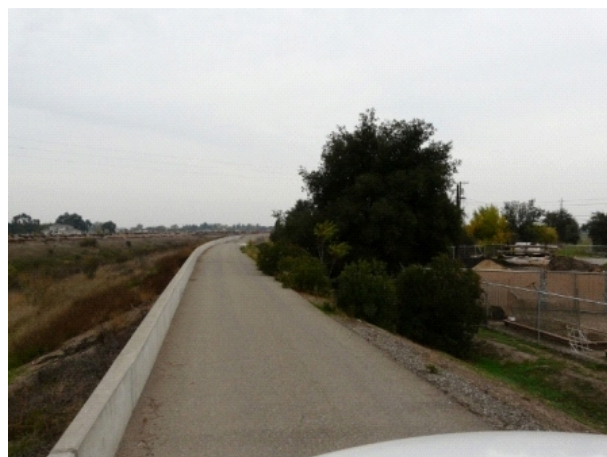
pkazi_s_20110328_084.JPG

Landscaping along landside slope of levee from LM 7.57 to 7.62

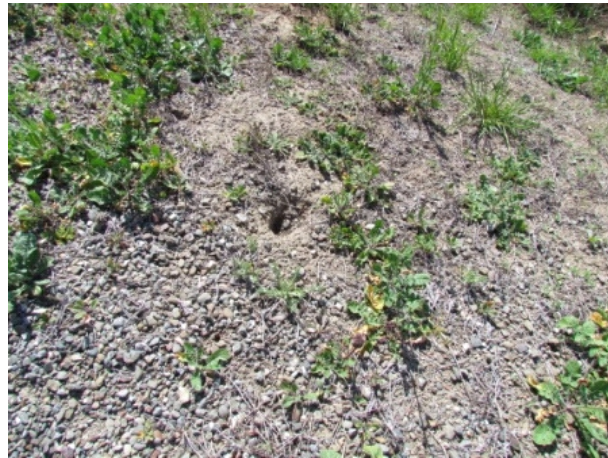
pkazi_s_20110502_493.jpg

Rodent hole exists on the landside of the levee. The picture was taken from the landside of the levee facing the crown of the levee.

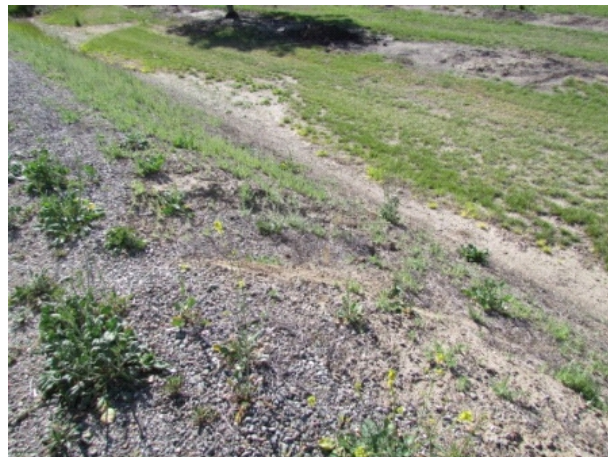
pkazi_s_20110502_494.jpg

Levee Mile Report Line	107
Start Levee Mile	8.57
End Levee Mile	8.57
Location	Land Side
Category	Earthen Levee
Item	Slope Stability

Slope erosion on the landside of the levee. The picture was taken from the crown looking towards the toe of the levee.

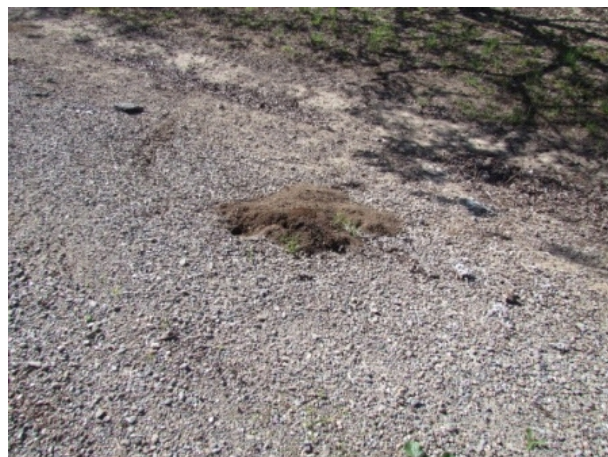
pkazi_s_20110502_495.jpg

Levee Mile Report Line	109
Start Levee Mile	8.69
End Levee Mile	8.69
Location	Land Side
Category	Earthen Levee
Item	Animal Control

Recent hole dug by the rodents at the landside of the levee, but no sign of any rodents around the area. The picture was taken from crown of the levee looking towards toe of the levee.

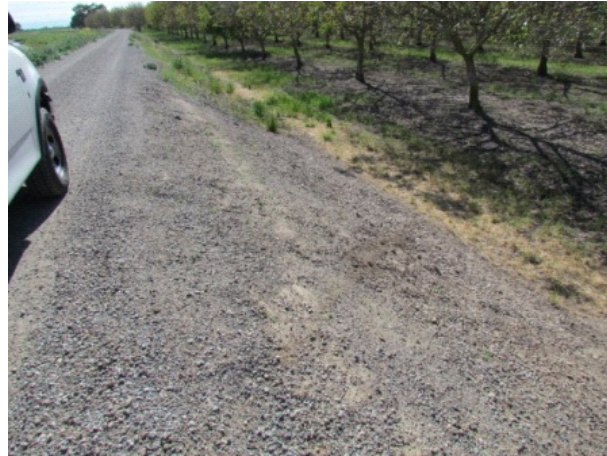
pkazi_s_20110502_508.jpg

The erosion on the landside of the levee was graded properly. The picture was taken from the crown of the levee looking upstream.

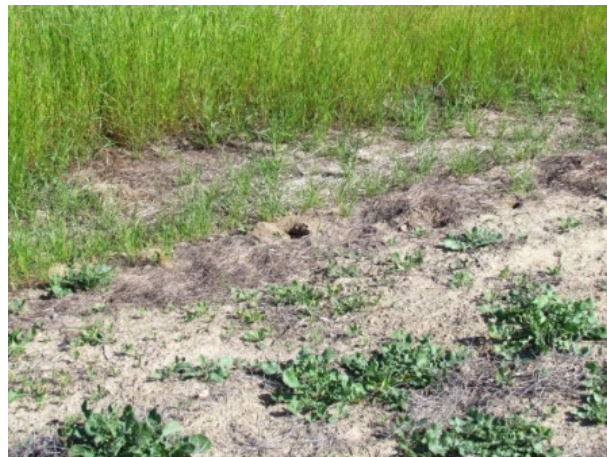
pkazi_s_20110502_497.jpg

Levee Mile Report Line	115
Start Levee Mile	9.36
End Levee Mile	9.36
Location	Water Side
Category	Earthen Levee
Item	Animal Control

Rodent hole at the waterside of the levee. The picture was taken from the crown of the levee looking upstream.

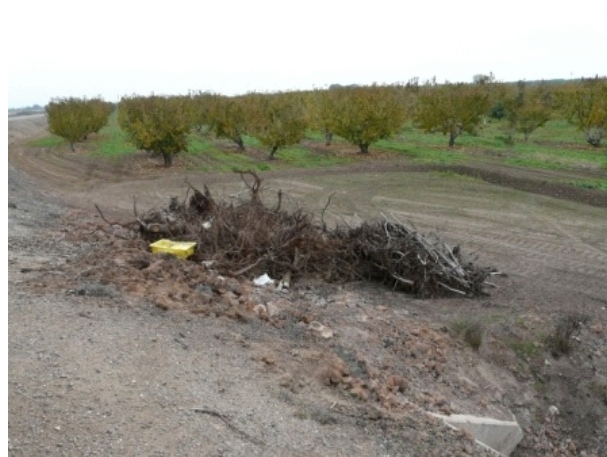
pkazi_s_20110328_085.JPG

Levee Mile Report Line	116
Start Levee Mile	9.52
End Levee Mile	9.52
Location	Land Side
Category	Earthen Levee
Item	Encroachments

Remove prunings from landside of levee at LM 9.52

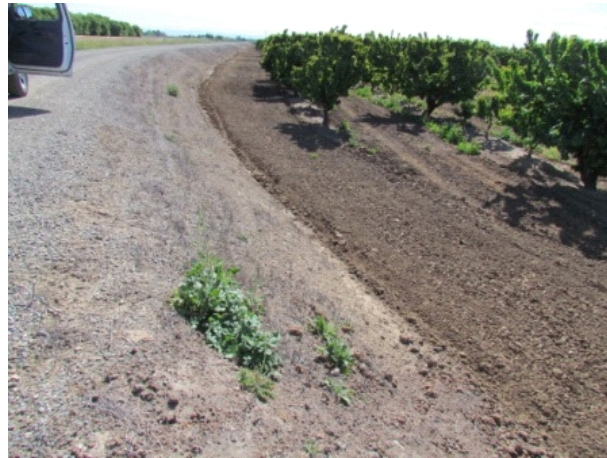
pkazi_s_20110502_498.jpg

Tilling was done by the farmers at the landside toe of the levee. The picture was taken from the crown of the levee looking upstream.

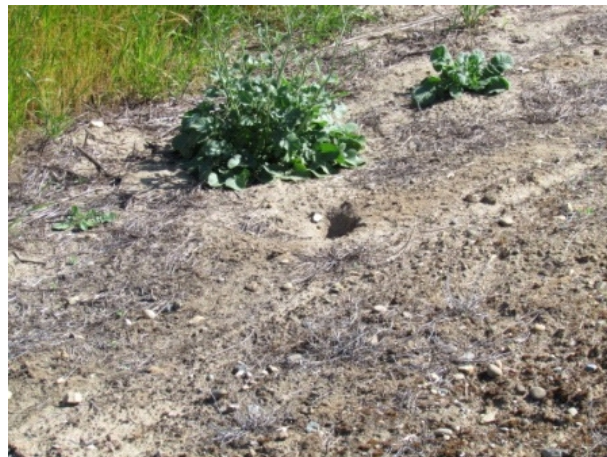
pkazi_s_20110502_499.jpg

Levee Mile Report Line	118
Start Levee Mile	9.61
End Levee Mile	9.61
Location	Water Side
Category	Earthen Levee
Item	Animal Control

Rodent hole at the waterside of the levee. The picture was taken from the crown of the levee looking upstream.

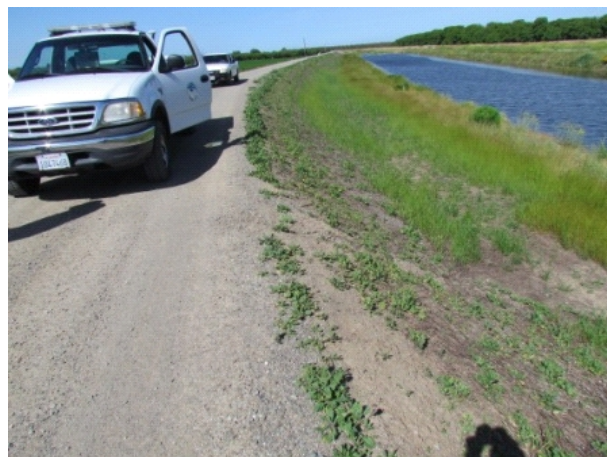
pkazi_s_20110502_500.jpg

Levee Mile Report Line	122
Start Levee Mile	9.93
End Levee Mile	9.93
Location	Water Side
Category	Earthen Levee
Item	Erosion / Bank Caving

The erosion on the shoulder of the waterside of the levee is fixed. The picture was taken from the crown of the levee looking downstream.

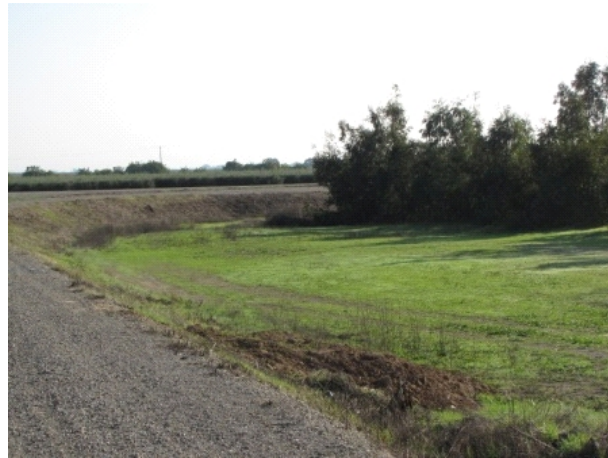
pkazi_s_20110328_079.jpg

View of soil placed on the landward slope looking upstream.

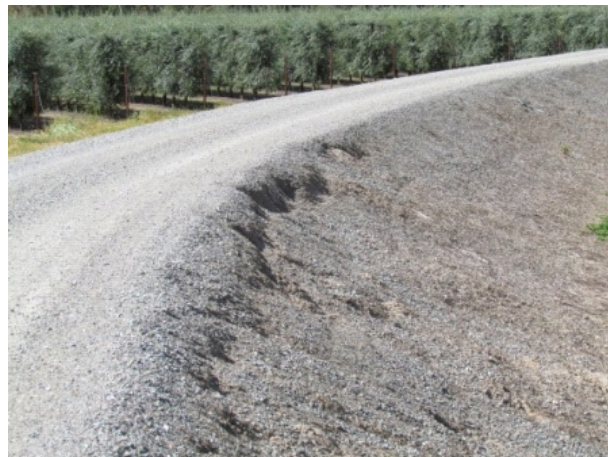
pkazi_s_20110502_509.jpg

Levee Mile Report Line	127
Start Levee Mile	10.68
End Levee Mile	10.68
Location	Water Side
Category	Earthen Levee
Item	Slope Stability

Sign of some erosion by foot traffic at the shoulder of waterside of the levee. The picture was taken from the crown of the levee looking downstream.

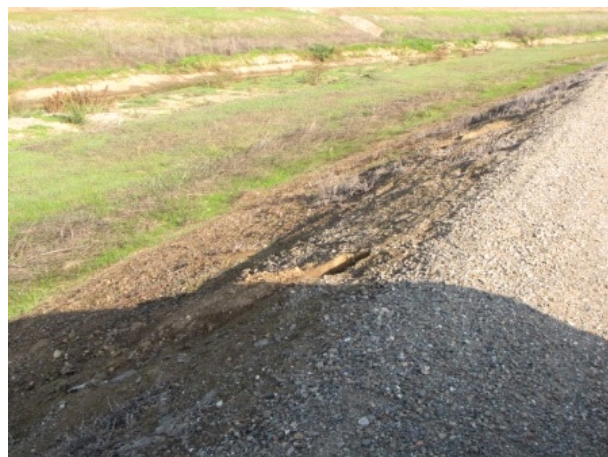
pkazi_s_20110328_080.jpg

Levee Mile Report Line	128
Start Levee Mile	10.78
End Levee Mile	10.78
Location	Water Side
Category	Earthen Levee
Item	Animal Control

View of rodent holes in the waterward slope looking upstream.

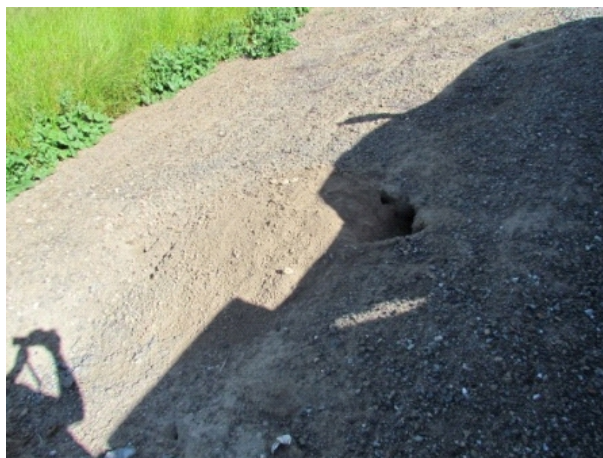
pkazi_s_20110502_510.jpg

Rodent hole at the waterside of the levee. The picture was taken from the crown looking upstream.

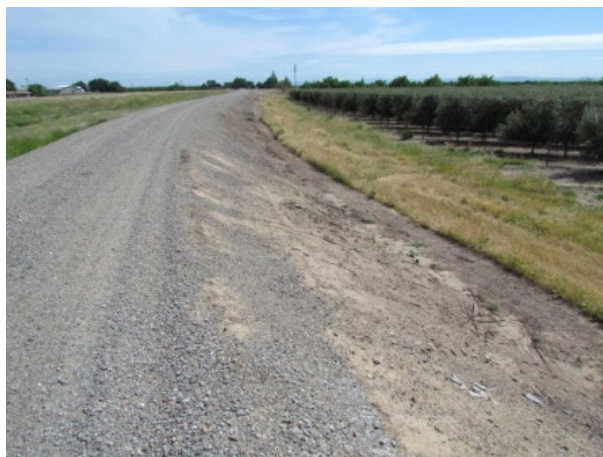
pkazi_s_20110502_511.jpg

Levee Mile Report Line	131
Start Levee Mile	10.83
End Levee Mile	10.83
Location	Land Side
Category	Earthen Levee
Item	Erosion / Bank Caving

The erosion on the landside of the levee has been graded. The picture was taken from the crown looking upstream.

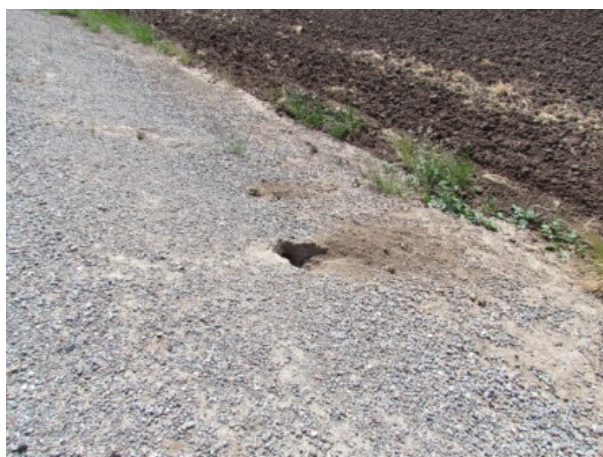
pkazi_s_20110502_512.jpg

Levee Mile Report Line	138
Start Levee Mile	11.22
End Levee Mile	11.22
Location	Land Side
Category	Earthen Levee
Item	Animal Control

Rodent hole was found on the landside of the levee. The picture was taken from the crown looking upstream.

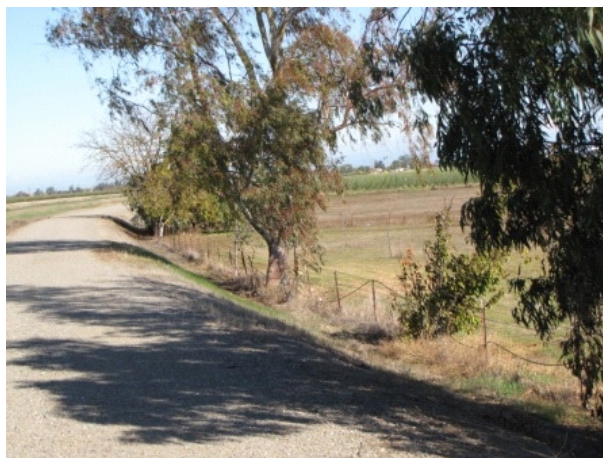
pkazi_s_20110328_142.jpg

View of a fence at the landward toe looking upstream.

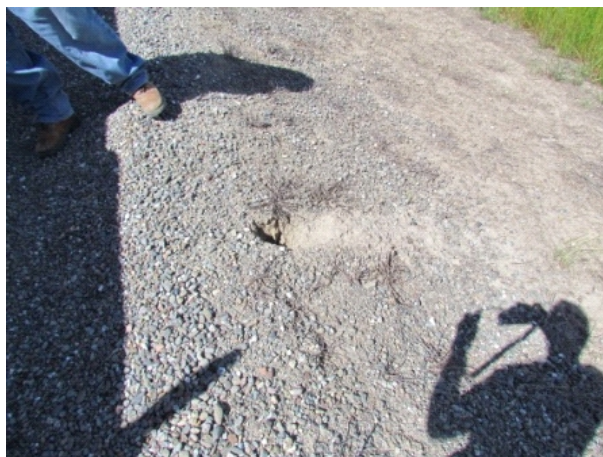
pkazi_s_20110502_513.jpg

Levee Mile Report Line	145
Start Levee Mile	11.90
End Levee Mile	11.90
Location	Water Side
Category	Earthen Levee
Item	Animal Control

Rodent hole at the shoulder at the waterside of the levee. The picture was taken from the crown looking downstream.

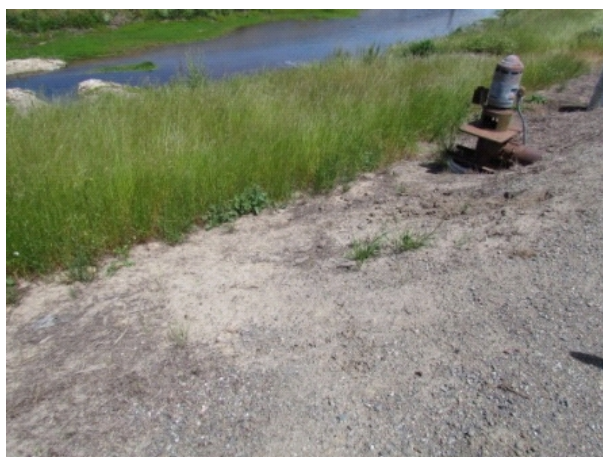
pkazi_s_20110502_514.jpg

Levee Mile Report Line	152
Start Levee Mile	12.93
End Levee Mile	12.93
Location	Land Side
Category	Earthen Levee
Item	Slope Stability

The depression on the waterside of the levee was graded by adding new material. The picture was taken from the crown looking upstream.

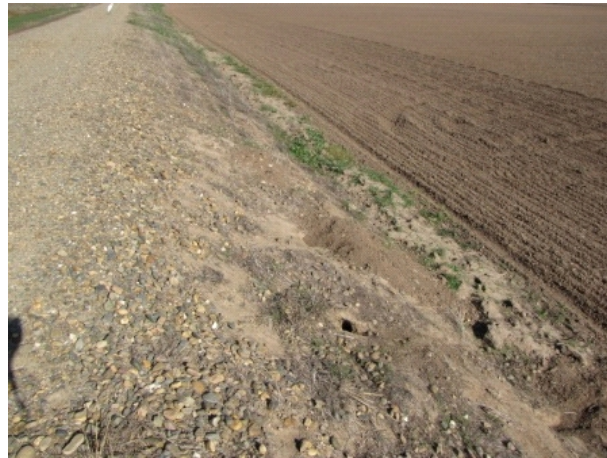
pkazi_s_20110328_143.jpg

View of rodent activity on landward slope looking upstream.

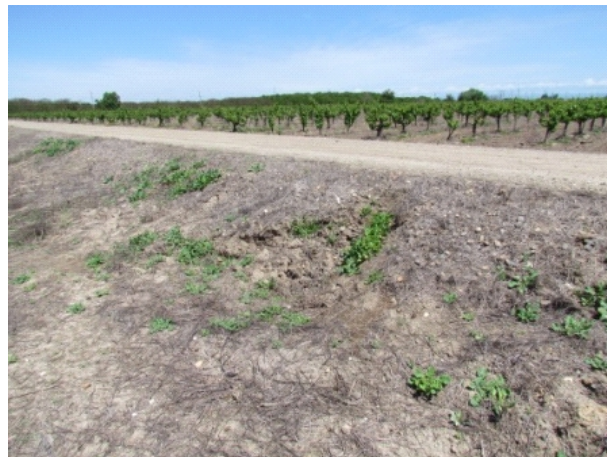
pkazi_s_20110502_515.jpg

Levee Mile Report Line	167
Start Levee Mile	14.53
End Levee Mile	14.53
Location	Water Side
Category	Earthen Levee
Item	Slope Stability

Depression on the waterside of the levee possible caused by foot traffic. The picture was taken from the toe of the waterside of the levee looking towards the crown.

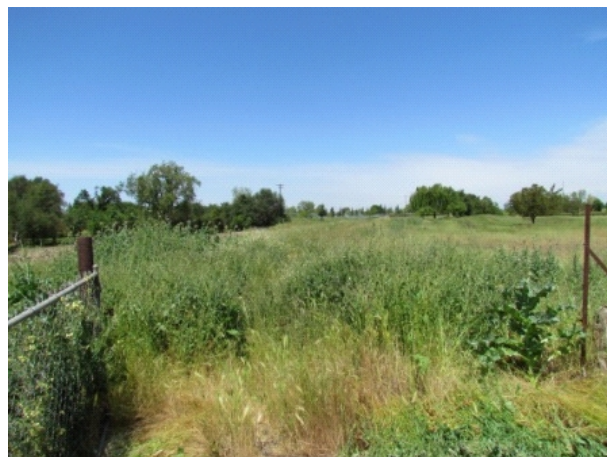
pkazi_s_20110502_516.jpg

Levee Mile Report Line	171
Start Levee Mile	15.24
End Levee Mile	15.32
Location	Crown
Category	Earthen Levee
Item	Vegetation

Vegetation taller than 3 feet covering the crown, waterside and landside. The picture was taken from the crown looking upstream.
